# Process Matters in Solving Critical Parts Cleaning Issues

Even though they didn't get the order, Hubbard-Hall's cleaning team used its process knowledge expertise to solve a \$1M issue for a defense manufacturer

Hubbard-Hall's cleaning team resolved a \$1 million inventory issue for a defense manufacturer by addressing process issues, not just cleaning chemistry. Despite not winning the product sale, their expertise led to the acceptance of 400 tubes, demonstrating a commitment to customer satisfaction and building confidence for future collaboration.

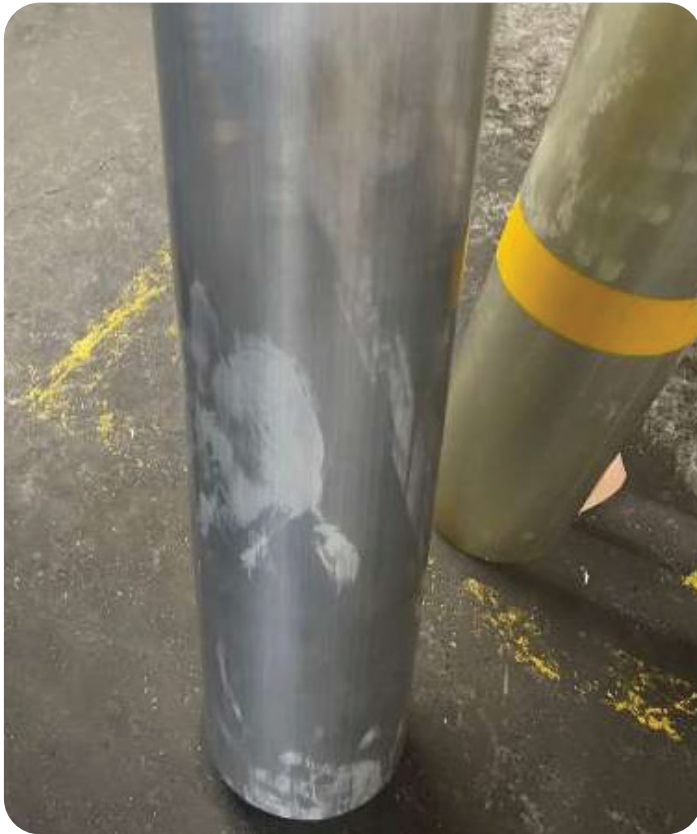
“It was ugly with visible lube remaining on the top of the tube,” Valenti says. “We noticed that when they set the cage of tubes down into the tank, the operator raised the cage up off the bottom. We asked why he did this, and he said the equipment manufacturer suggested this to keep the cage off the bottom of the tank to avoid excess wear on the tank bottom.”

The Hubbard-Hall team discussed alternative fixturing of the parts and tried several different ways before determining that the original fixturing method was best for this application. Holloway and Valenti had them put the load back in, but this time directed the operator to put it all the way down. This proved to show a dramatic improvement in removing the lube, but a staining pattern was already present where the excessive lube contacted the tube.

The Hubbard-Hall team also noticed that it appeared that the ultrasonic energy might not be hitting all the surfaces of the tubes. They lowered the cage to the bottom of the cleaning tank and observed a noticeable improvement in removing the lube. Valenti also had them increase the energy of the transducers.
